Full investigation of the accident scene can reveal other responsible parties

WHEN THE PRIMARY DEFENDANT IS UNDERINSURED, A THOROUGH INVESTIGATION OF THE ACCIDENT SCENE CAN YIELD SURPRISING EVIDENCE OF NEGLIGENCE BY OTHER PARTIES

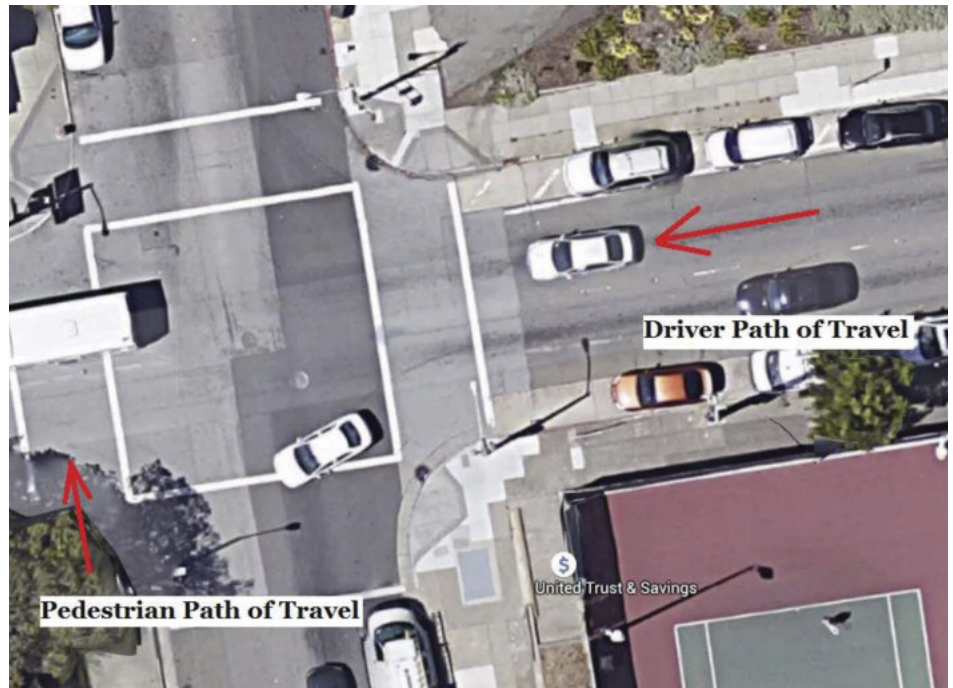
Concrete truck impeding sightlines

Notice that the concrete truck was parked toward the front of the construction site, but fully within the construction site. In this intersection, there are two traffic lights: one on each side of the intersection, on the opposite side of the street at about 10 feet off of the ground. There is no center traffic light positioned directly in front of westbound traffic on Turk.

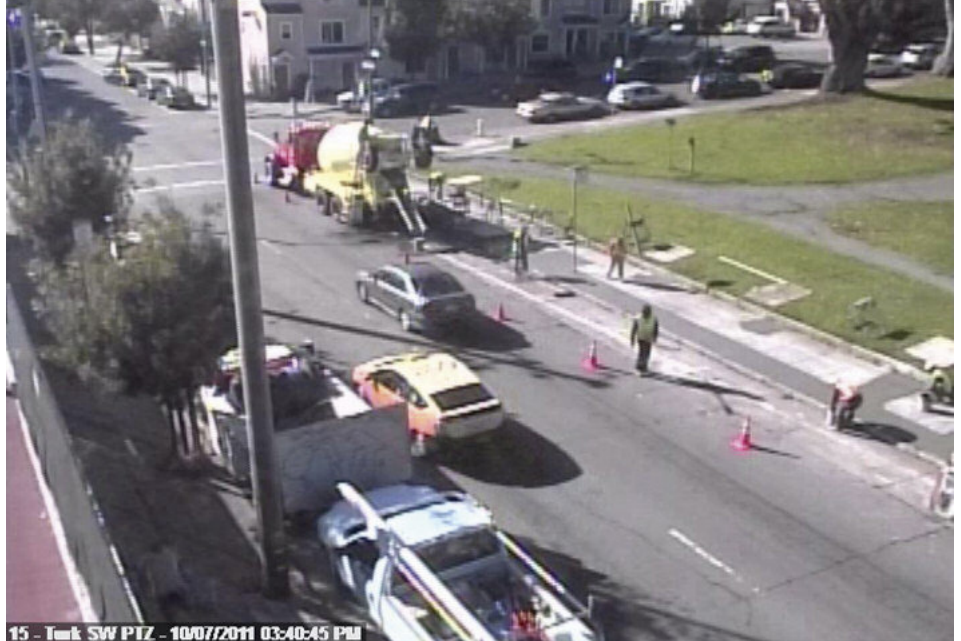
This frame-grab was taken from a security camera on a nearby building just seconds before impact.

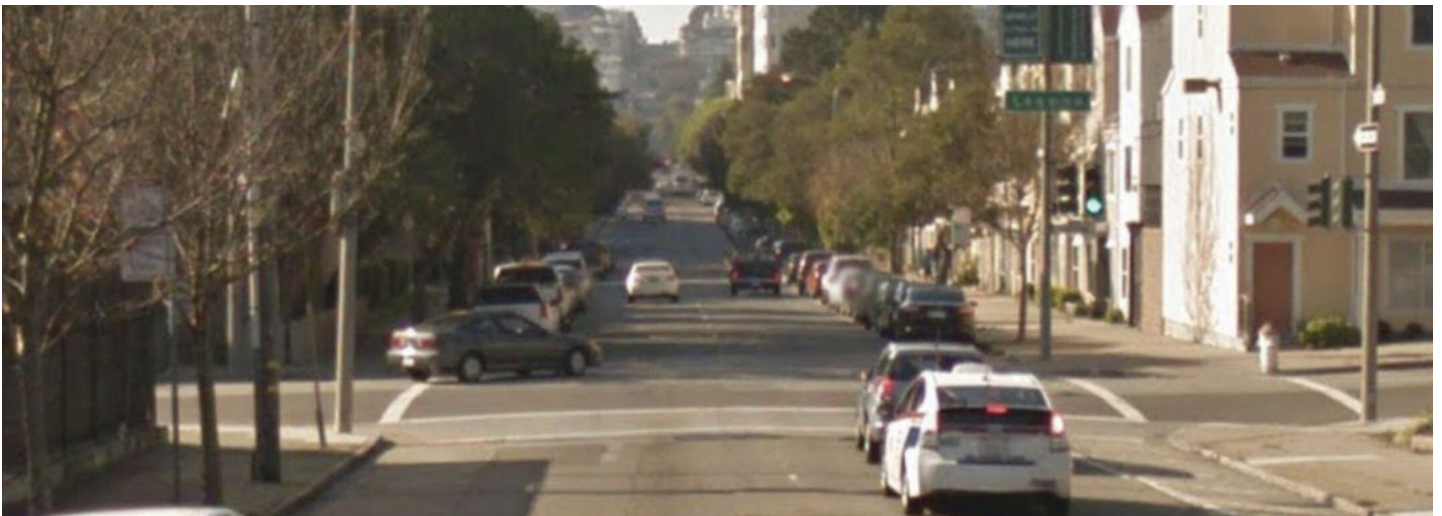
165 Feet; 3.75 seconds before intersection – left traffic light blocked by tree.

After a visit to the scene of the incident, it became clear that the left traffic light was completely obscured from westbound traffic until about 165 feet, or 3.75 seconds before the driver entered the intersection (at 25 mph). Under normal conditions, the right traffic light was open and visible for over 500 feet before the intersection.

Below are Google Street View pictures showing the left light sightline impediments as the driver approached the intersection.

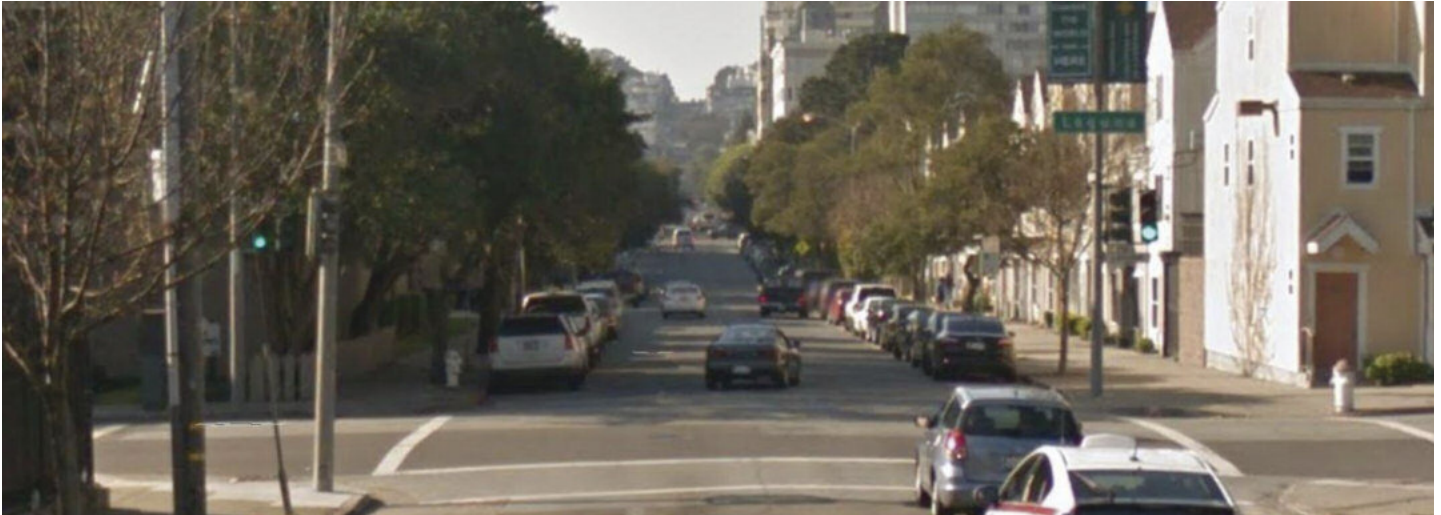
130 feet; 3 seconds before intersection – first glimpse of left traffic light.

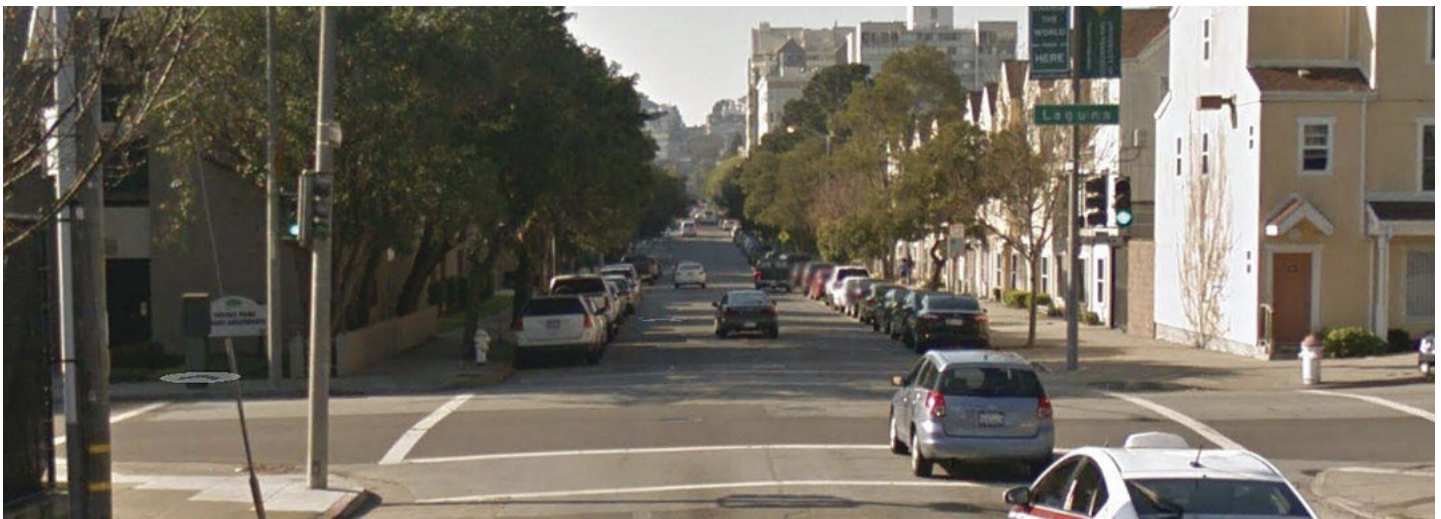
95 feet; 2 seconds before intersection – traffic light about to be obscured by Laguna traffic light and pole.
